**SURFACE ROUGHNESS OF ELECTRON BEAM MELTING TI-6AL-4V  
EFFECT ON ULTRASONIC TESTING**

THESIS

Evan T. Hanks, Captain, USAF

AFIT-ENY-MS-16-M-216

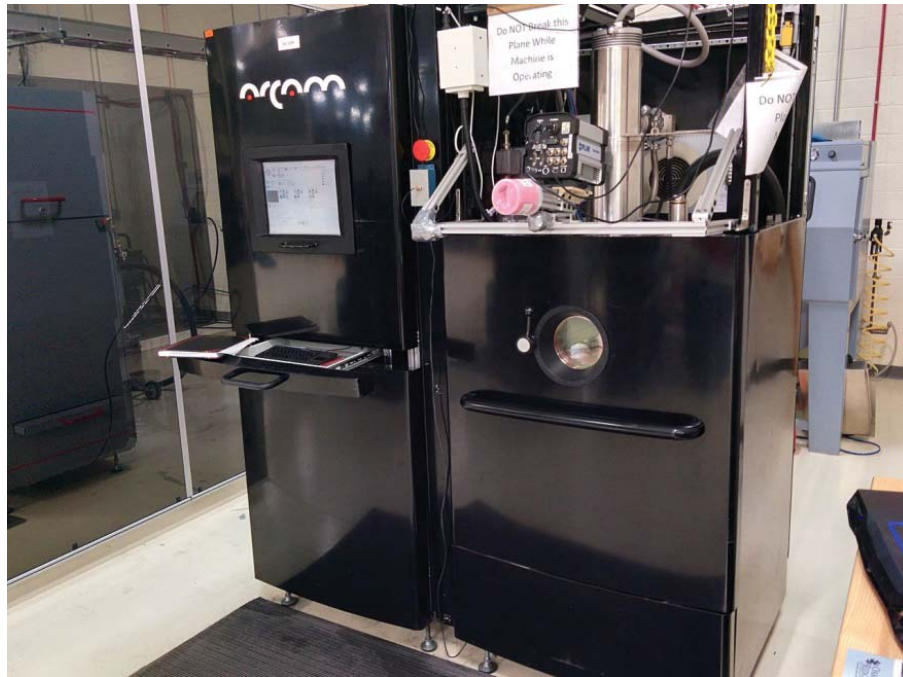
**Figure 15.** Arcam A2 system [20]

were manufactured on Arcam's newer Q10 system. All samples were manufactured with the X-axis of the sample parallel to the X-axis of the AM machine's power bed. The A2 system has a larger build envelope while the Q10 has a smaller height of build envelope as seen in Table 2.

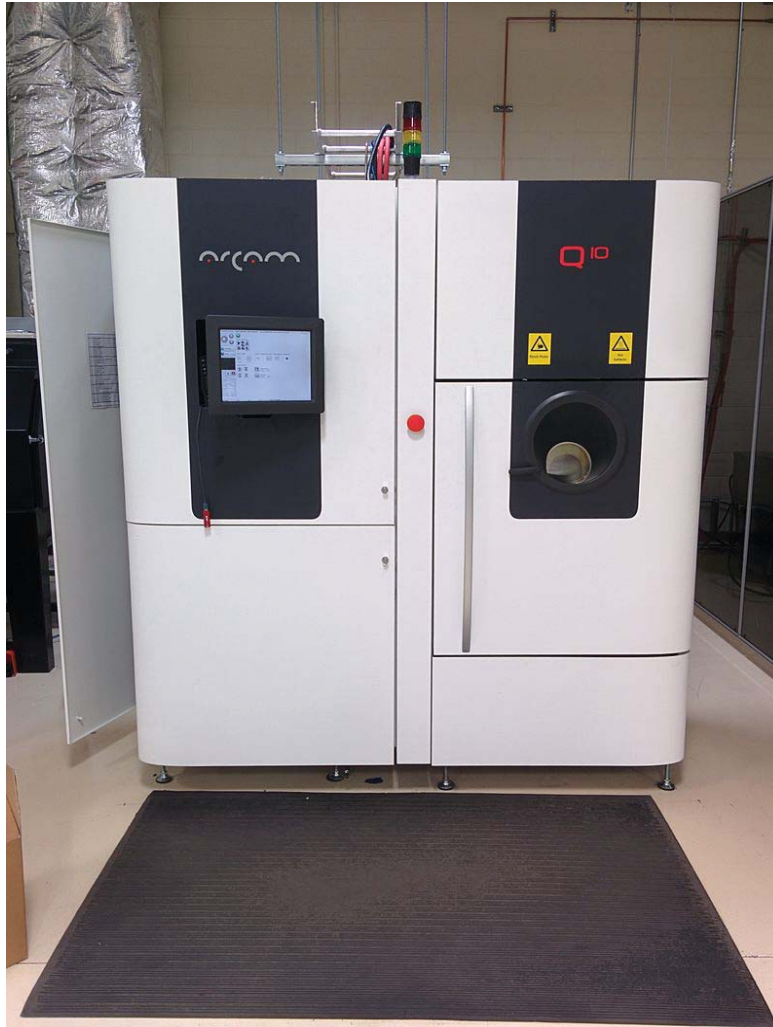
**Figure 16.** Arcam Q10 System [34]

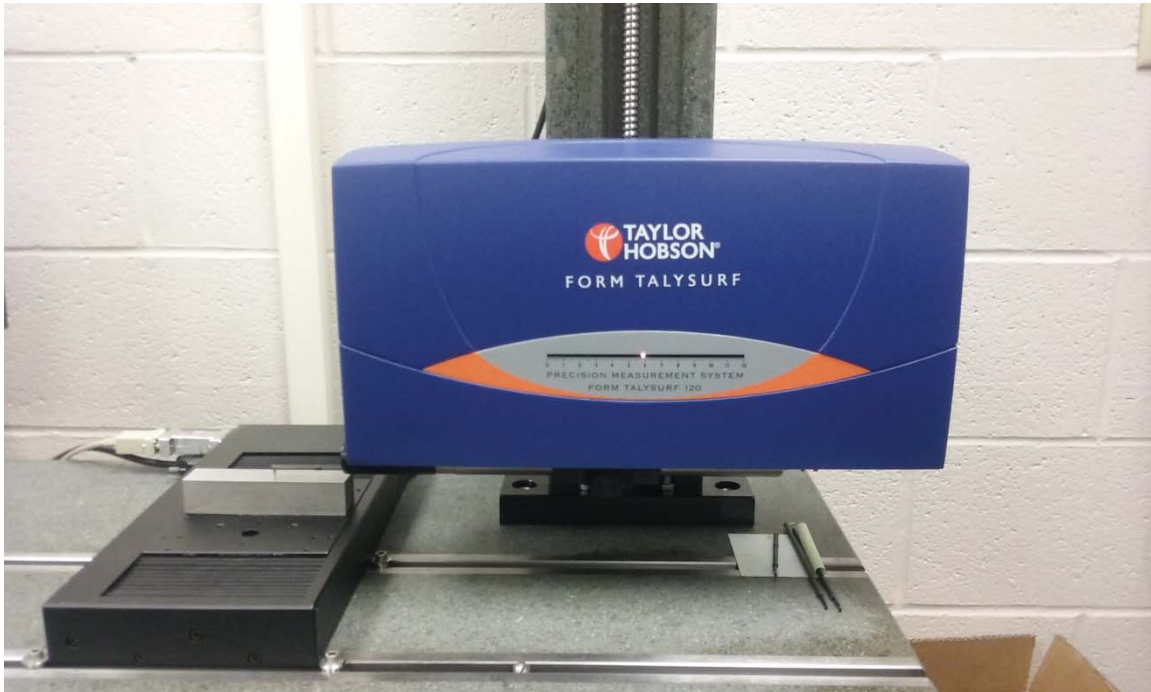
**Figure 17.** Profilometer set-up, used to generate 3-D surface roughness measurements

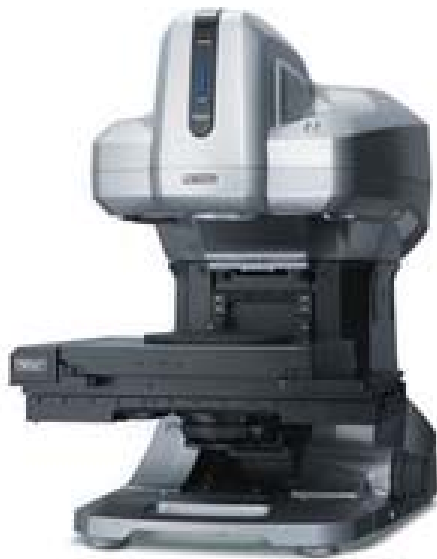
**Figure 18.** 3-D Measuring macroscopic, Keyence Model VR-3200

The Taylor-Hobson Form Talysurf 120 has a maximum range of 120  $\mu\text{m}$ . Following multiple attempts to measure the side surface with this particular profilometer, the surface was determined as above the range of measurement. Alternate methods were explored and the method of measurement ultimately decided on was a 3D Measuring

Macroscopic, shown in Figure 18. The 3D Measuring Macroscopic provided similar results to the profilometer. The top surface of samples B-42 and M-42 were measured using both methods as a comparison. The resulting measurements of sample B-42 were 21.2  $\mu\text{m}$  RMS using the profilometer and 20.25 $\mu\text{m}$  RMS with the Macroscopic, providing approximately a 4% difference. Sample M-42 provided results of 15.8  $\mu\text{m}$  RMS and 15.76  $\mu\text{m}$  RMS, a difference of 0.2% between measurement methods. Due to resource constraints, only sample -42 from each set was measured for side surface roughness. It is assumed samples from the same production run, both sample -41 and -42, have the same side surface roughness. Figure 19 is a representative image taken with a scanning electron microscope of the side surface of a sample. Figure 19 shows the surface irregularity and several partially adhered grains using a scanning electron microscope.

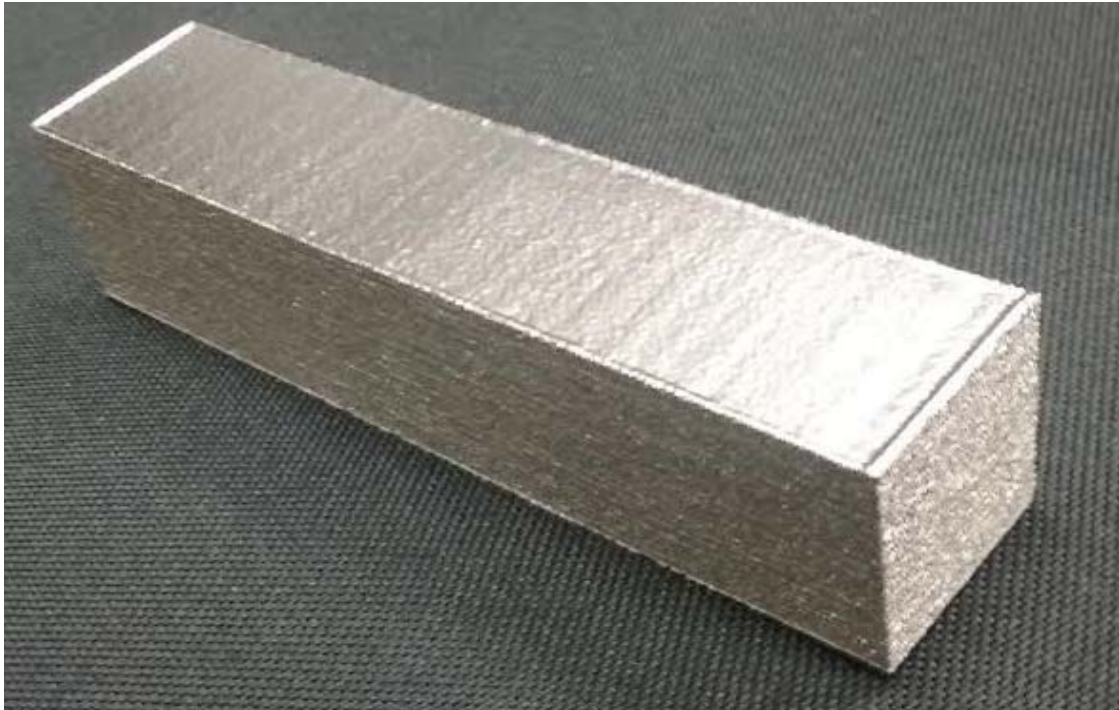
**Figure 26.** Sample B-41 top and side surfaces prior to machining.

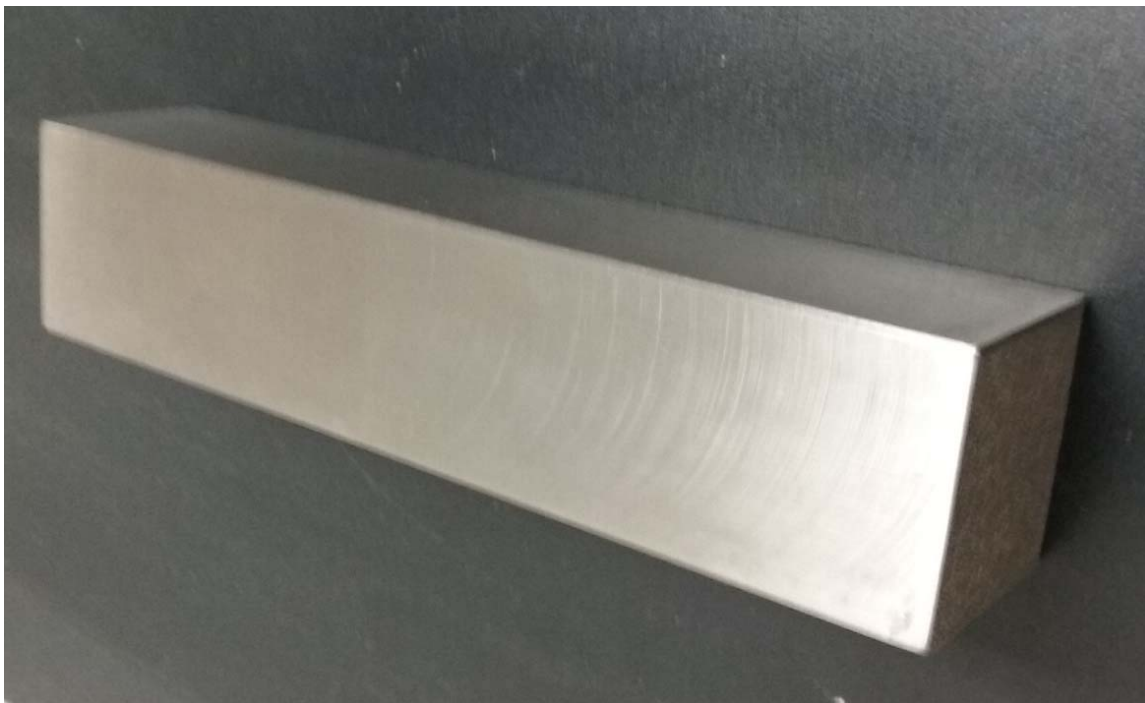
**Figure 27.** Sample B-41 top and side surfaces post machining, tooling marks visible on both surfaces

Upon completion of UT on all as-manufactured specimens, post process machining was accomplished. Of each set of specimens, -41 was selected to have the upper and side surfaces milled smooth. Sample -42 of each set was not machined and held as a control, also allowing for future testing of as-manufactured specimens. A shell cutter was used on a three axis mill to remove surface roughness. Planarity was maintained using the mill bed while the minimum amount of material was removed to create a new surface. Figure 26 shows the upper and side surfaces before machining; a slight ridge is seen around the upper perimeter from the manufacturing process. The newly machined surfaces are shown in Figure 27 where only minor tooling marks remain.

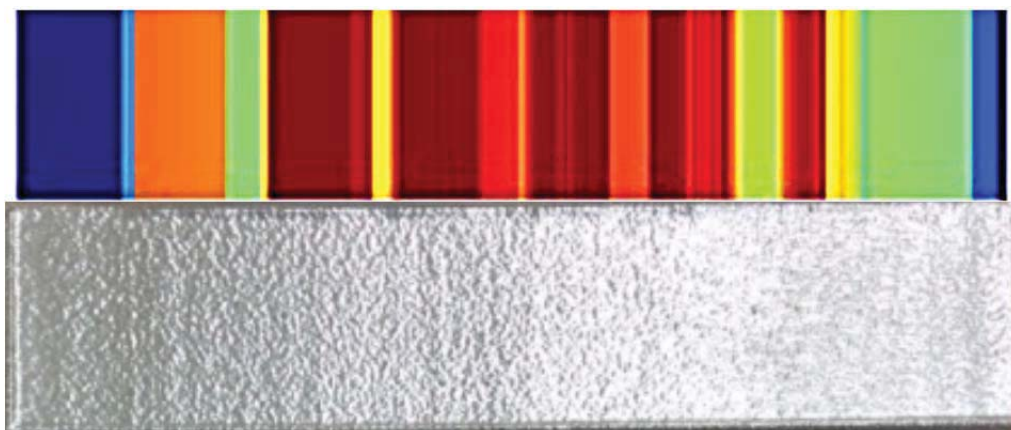
**Figure 37.** Beam current map compared to surface striations, Sample A-42 [39]

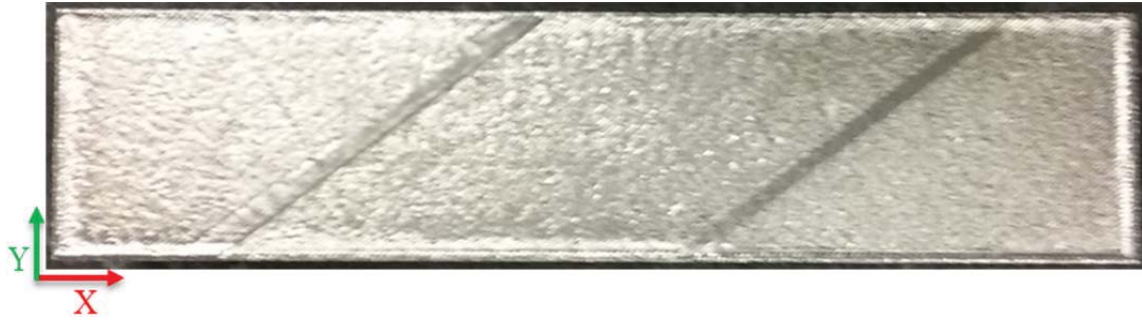
**Figure 38.** Sample L-41 top surface, visible diagonal striations on top surface due to beam pattern variation.

Previously mentioned in Chapter 3, samples L and M were manufactured on Arcam's Q10 as opposed to the A2 system used for all other samples. The Q10 system uses a different algorithm to determine electron beam pattern and intensity from the A2. Detailed information of the beam current across the build area was not investigated in as much depth for the Q10 system. The Q10 is a newer generation of technology and the software used to control the build is still periodically updated. It is known the Q10 system does not restrict the electron beam to patterns strictly in the X or Y direction, but allows diagonal melting of the powder on the build surface. The diagonal pattern, seen in Figure 38, is created by boundaries imposed by the manufacturing software. The markings on all samples are minor enough to where they are undistinguishable from the surrounding surface using a surface profilometer.

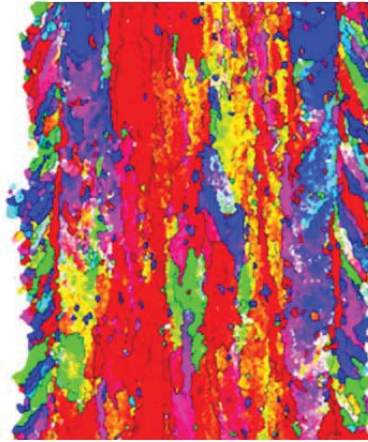
**Figure 45.** Electron Back Scatter (EBSD) map from X–Z cross sections [25]
